EXTERIOR RESTORATION

James and Ann Whitall House
100 Hessian Avenue, National Park, NJ 08063

Westfield Architects & Preservation Consultants
425 White Horse Pike, Haddon Heights, NJ 08035

FOR BIDDING
REV. 8/2/24

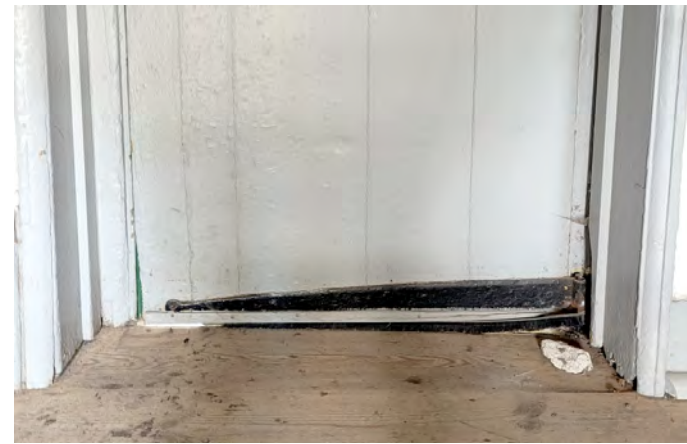
D EXTERIOR DOOR HARDWARE
RESET DOOR HARDWARE AFTER REPAIRS TO DOOR, SECURE ESCUTCHEON.

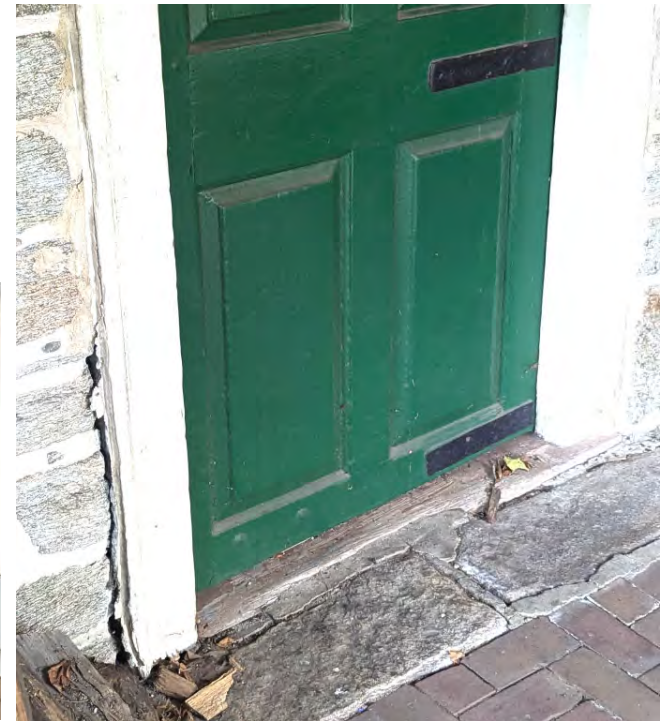
G DOOR D4
REPAIR FRAME, REHANG DOOR, PATCH MORTAR, CAULK JAMBS & HEAD. INSTALL NEW SILL WEATHERSTRIPPING.

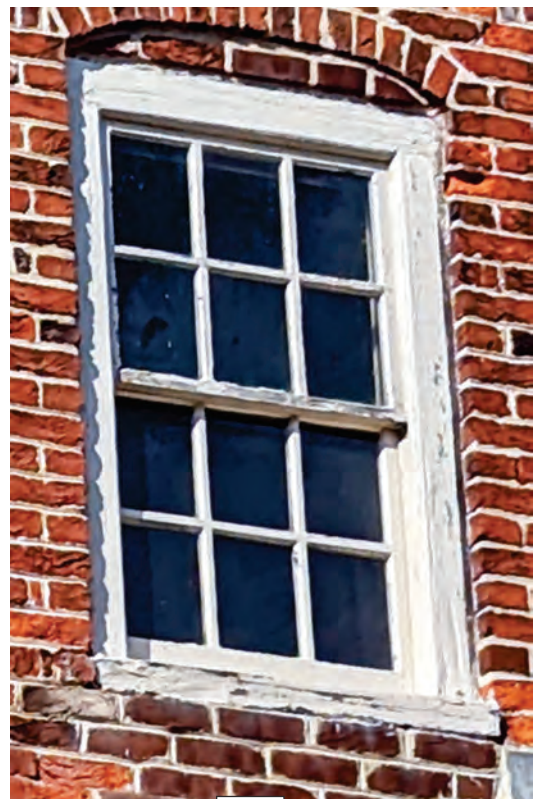
F WINDOW W7
EPOXY REPAIR SHOW SILL.

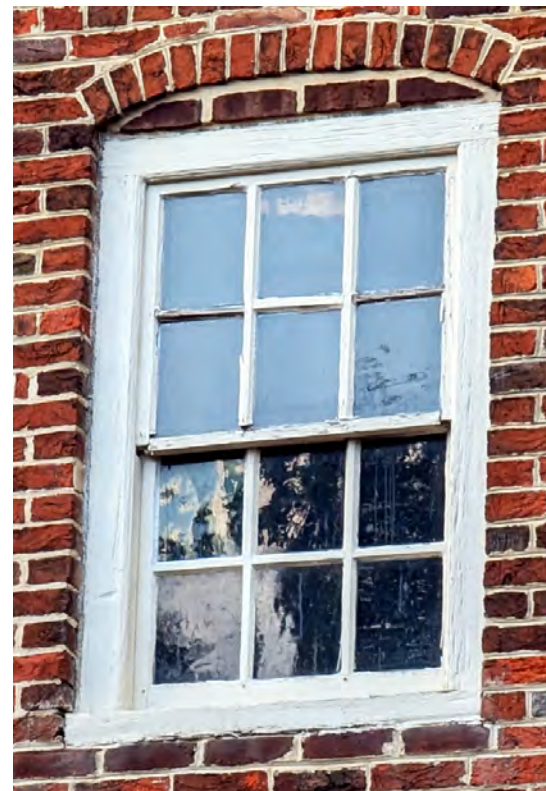
G WINDOW W8
REPAIR & REGLAZE UPPER SASH.

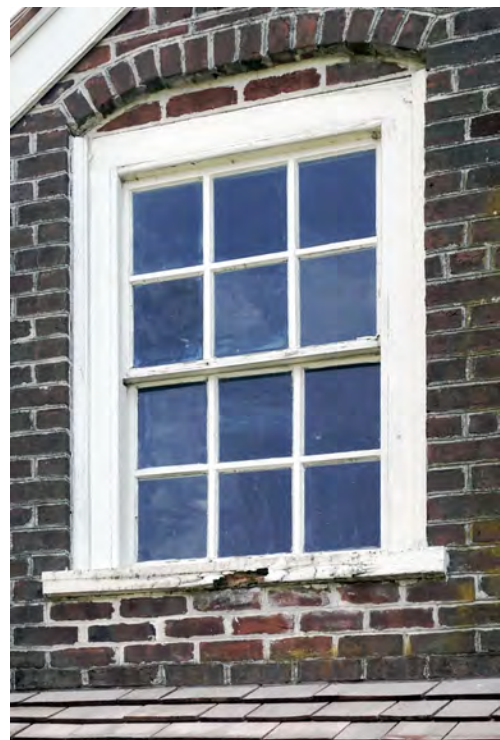
H WINDOW W6
EPOXY REPAIR SHOW SILL.

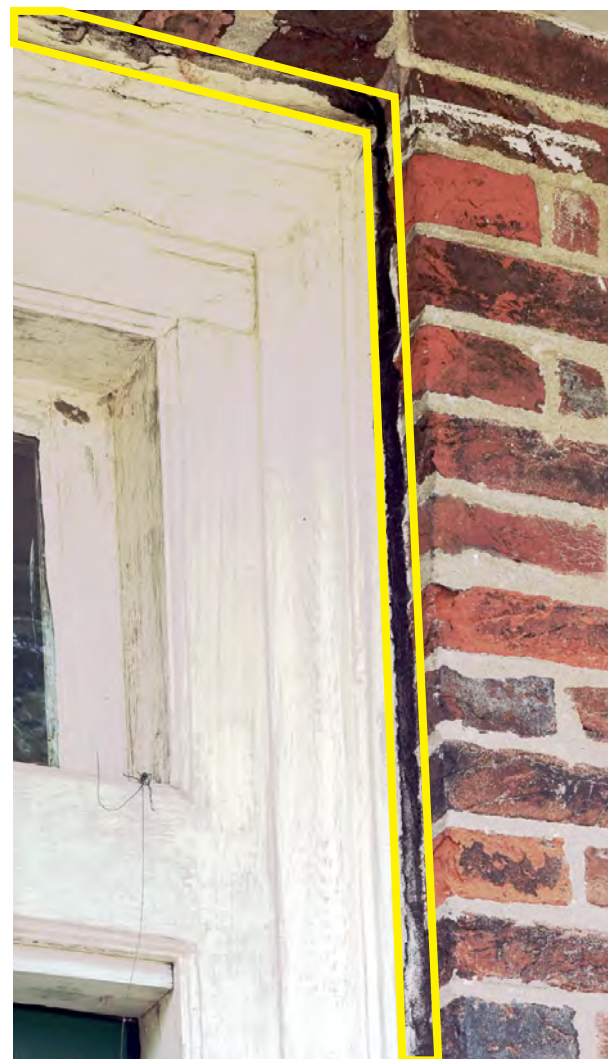
E CAULK & SEALANT REPLACEMENT
EXAMPLE OF WHERE DETERIORATED OR INAPPROPRIATE CAULK NEEDS TO BE REMOVED, TYPICAL FOR ALL BUILDING AREAS. REPLACE WITH BACKER ROD WHERE NEEDED AND SEALANT OR CAULK PER SPECIFICATIONS.

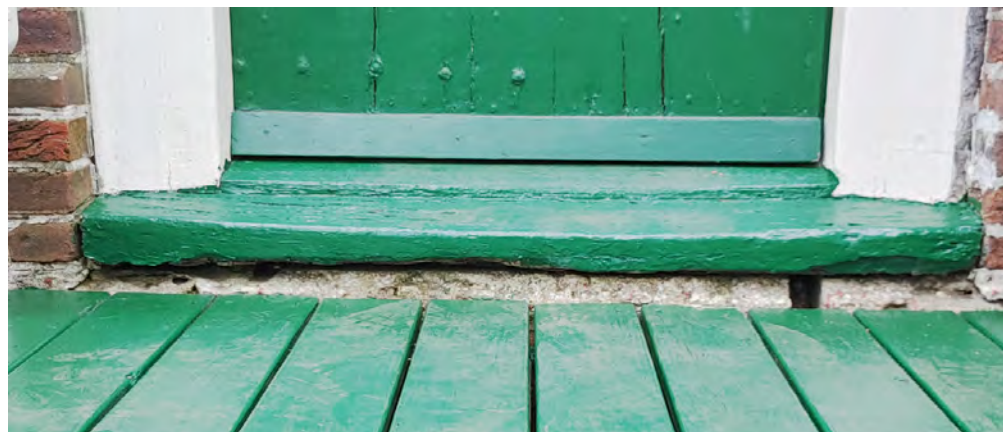
D EXTERIOR DOOR SILL

DOOR D5
REMOVE LOOSE MORTAR BELOW DOOR SILL & PATCH w/ MORTAR, CAULK JOINT AT UNDERSIDE OF WOOD SILL.

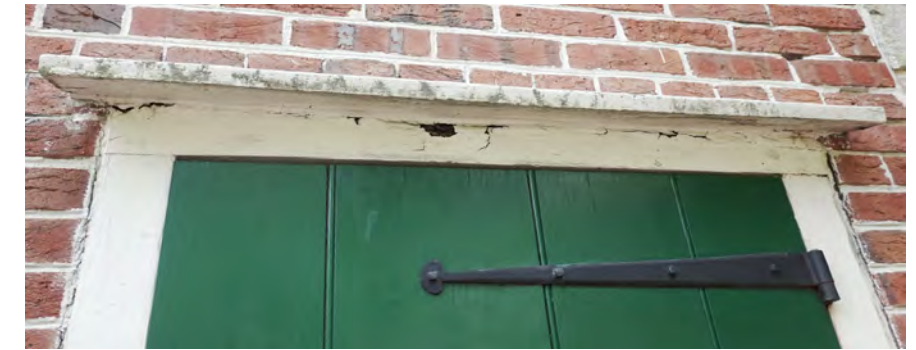
C EXTERIOR DOOR HEAD
REPAIR DOOR HEAD TRIM.

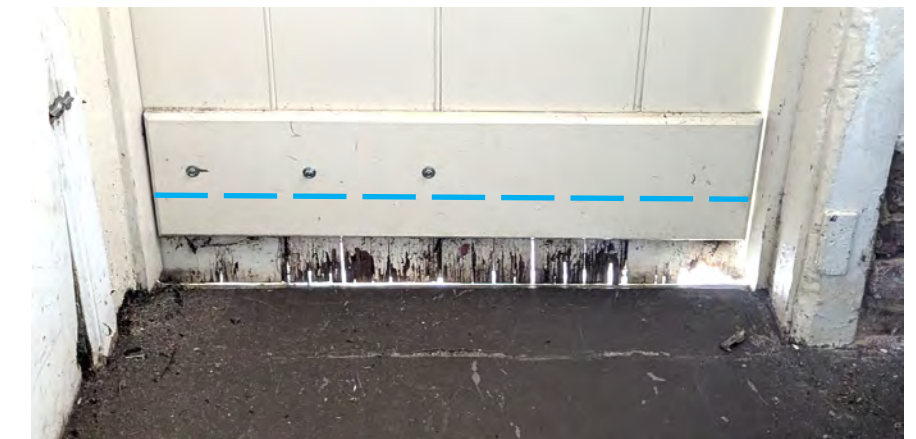
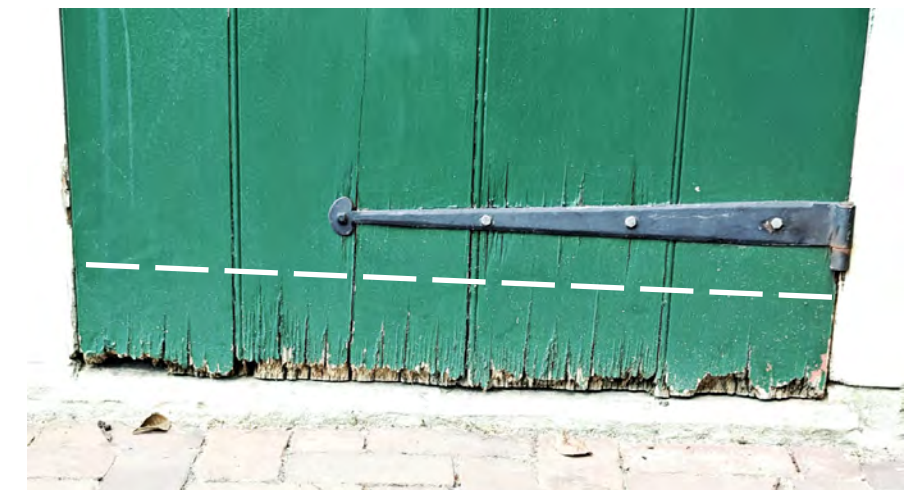
B INTERIOR BOTTOM OF DOOR

A EXTERIOR BOTTOM OF DOOR

DOOR D3
KERF CUT DETERIORATED LOWER DOOR BOARDS AT THE LOWER BATTEN. ATTACH NEW BOARDS TO BATTEN & FILL JOINT SEAM WITH EPOXY. ADD WATERTABLE TO BASE SIMILAR TO DOOR D1.

REPAIR FRAME AT HINGE LOCATIONS. RE-SECURE HINGES TO FRAME & REHANG DOOR.

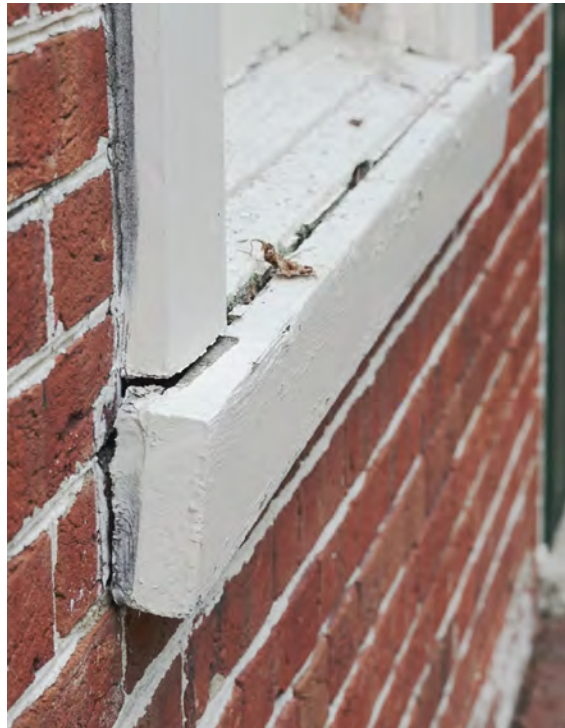
E SILL

WINDOW **W4**

REPAIR & RESET EXTERIOR SILL

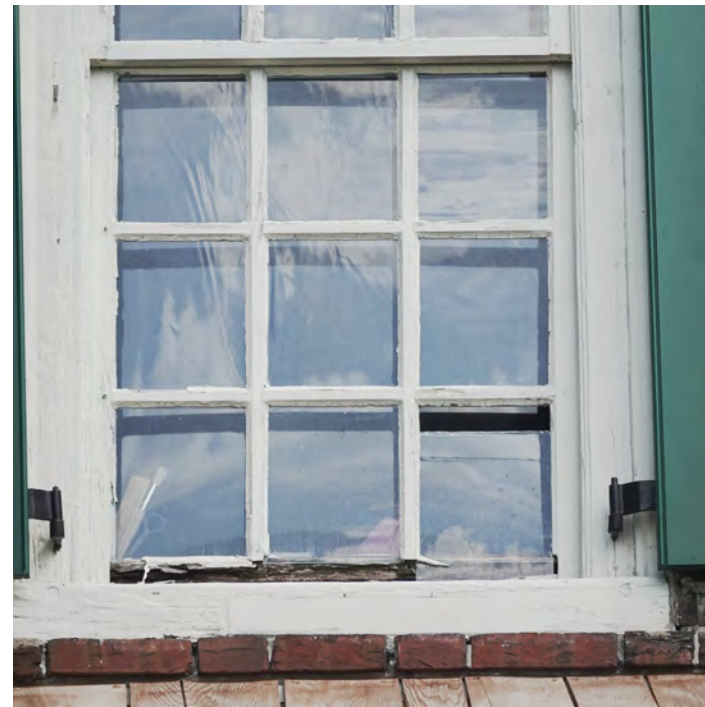
F LOWER SASH

WINDOW **W5**

REMOVE LOWER SASH TO MAKE WOOD REPAIRS.
(ALSO NOTE REPOINTING NEEDED AT BRICK SILL.)

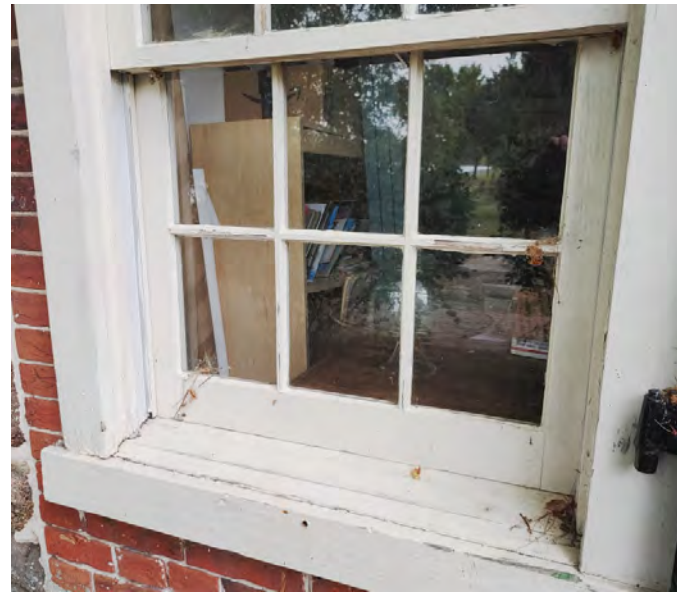
D EXTERIOR & INTERIOR VIEWS OF WINDOW

WINDOW **W3**

REPLACE LOWER SASH. MATCH DETAILING OF UPPER SASH. INSTALL LATCH AT MEETING RAIL.

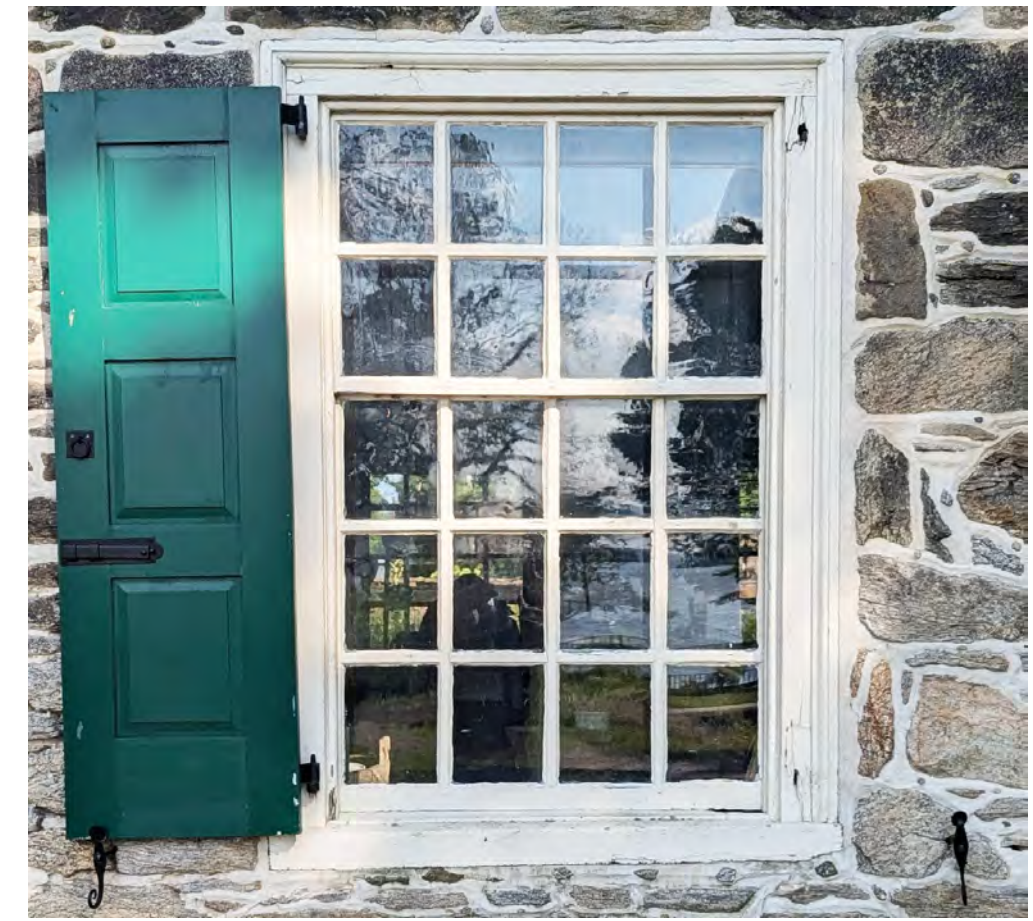
A WINDOW w/ MISSING SHUTTER & PINTLES

WINDOW **W1**

EPOXY REPAIR WINDOW JAMB TRIM AT ALL PINTLE LOCATIONS. REINSTALL SHUTTER
HARDWARE & REHANG SHUTTERS.

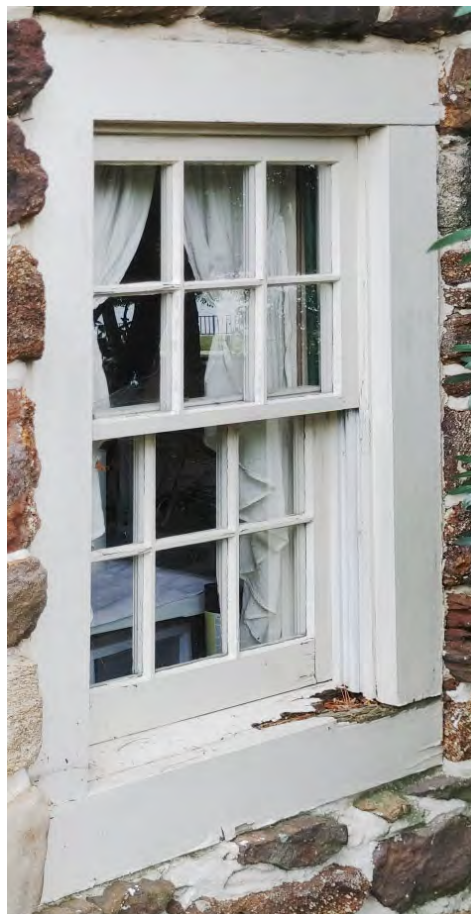
A PHOTO OF EXISTING WINDOW TO BE REPLACED

REMOVE ENTIRE EXISTING WINDOW, FRAME & TRIM. ENSURE BLOCKING @ OPENING IS SUFFICIENT FOR NEW WINDOW. INSTALL NEW WINDOW & TRIM. REPOINT ANY LOOSE OR MISSING MORTAR AT OPENING PER UNIT PRICE.

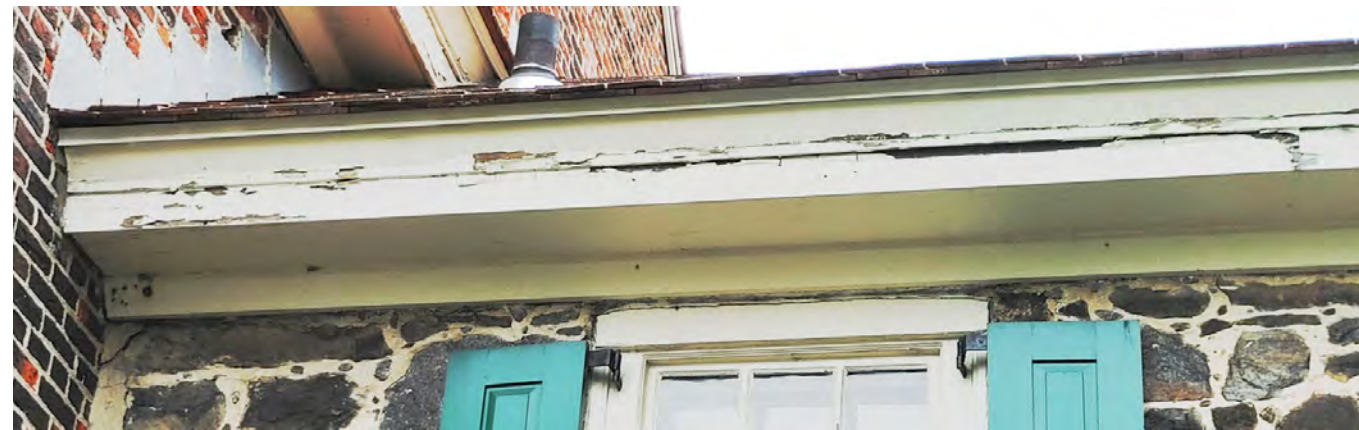
G WOOD REPAIR EXAMPLES OF TYPICAL CONDITIONS IN NEED OF REPAIRS @ CORNICE, FASCIA, RAKE BOARD & MOLDING - SEE ELEVATION PHOTOS FOR SPECIFIC LOCATIONS.

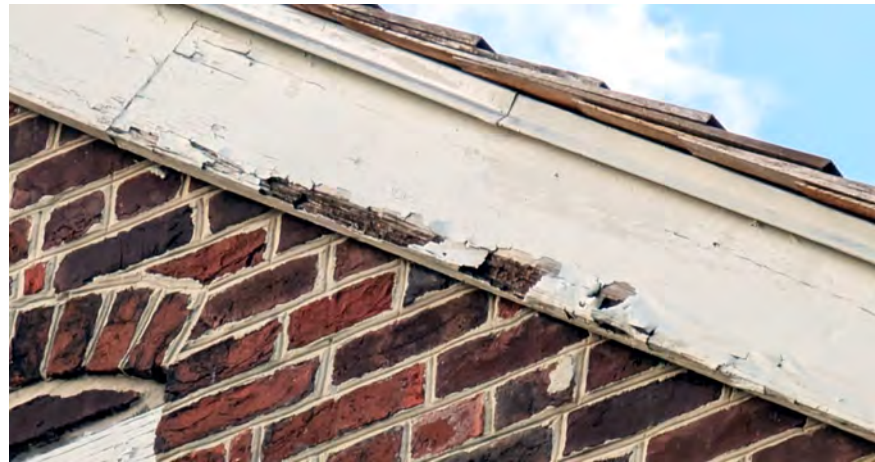
E WOOD REPAIR
REPAIR GABLE END RAKE BOARD

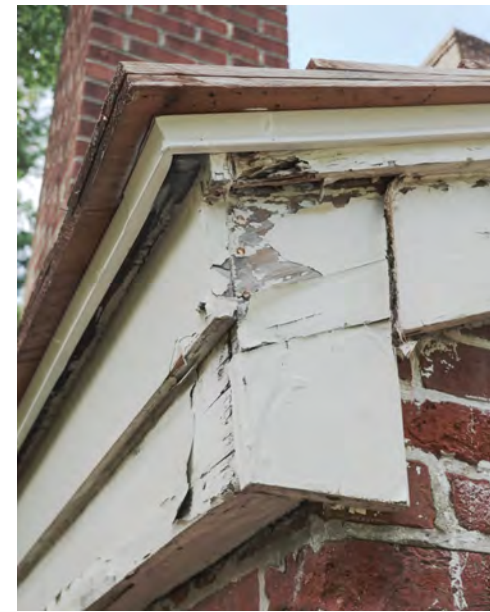
D WOOD REPAIRS
REPAIR CORNICE AND FASCIA BOARDS AT CORNER RETURN.

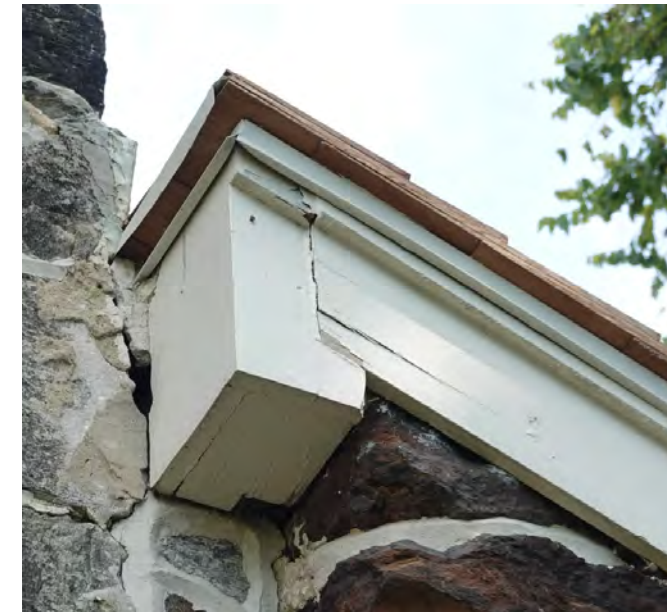
C WOOD REPAIRS AT ROOF
REPAIR FASCIA & RETURN CORNICE MOLDINGS AT SHED ROOF. FILL HOLE IN MASONRY W/ BACKER ROD, TUCK POINT & CAULK BETWEEN WOOD & MASONRY

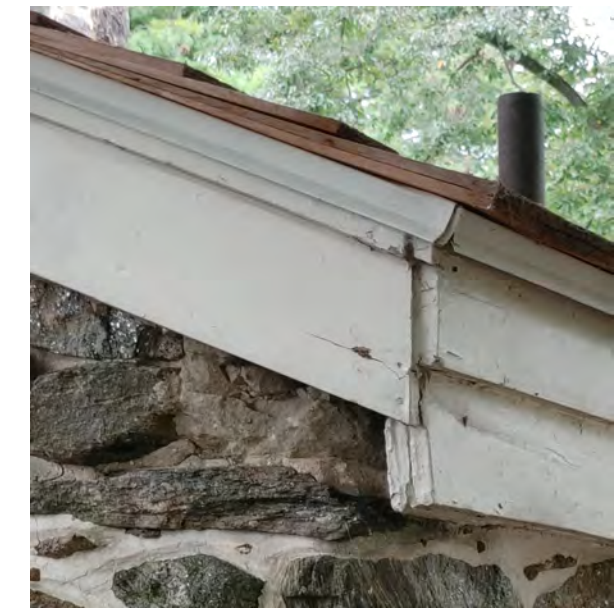
D WOOD REPAIRS @ ROOF
REPAIR FASCIA. INSTALL MISSING TRIM TO MATCH RETURN ON OPPOSITE (EAST) CORNER

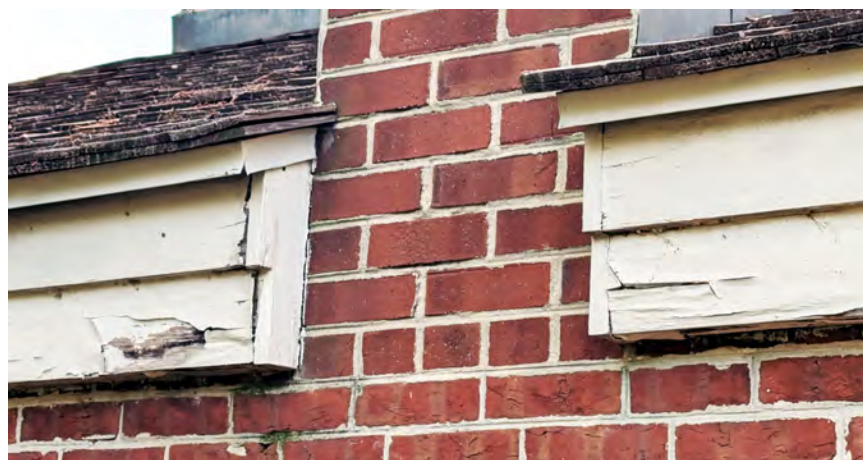
F WOOD REPAIRS
REPAIR CORNICE FASCIA & MOLDING.

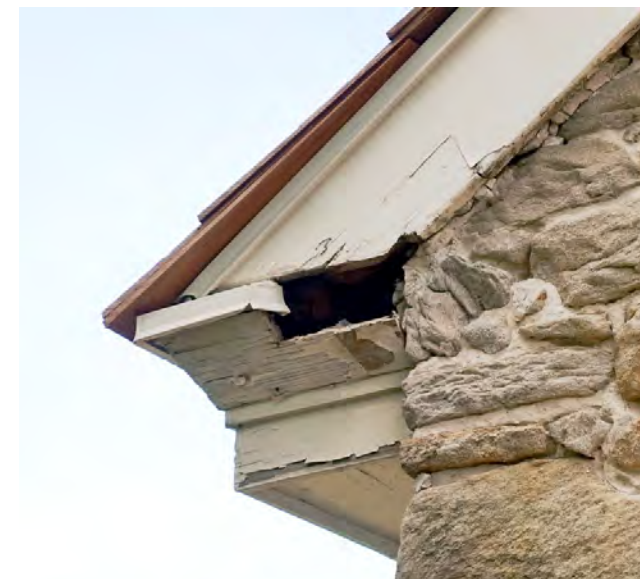
A WOOD REPAIRS @ CORNICE
REPAIR CORNICE RETURN TO MATCH CONFIGURATION OF OPPOSITE (EAST) SIDE

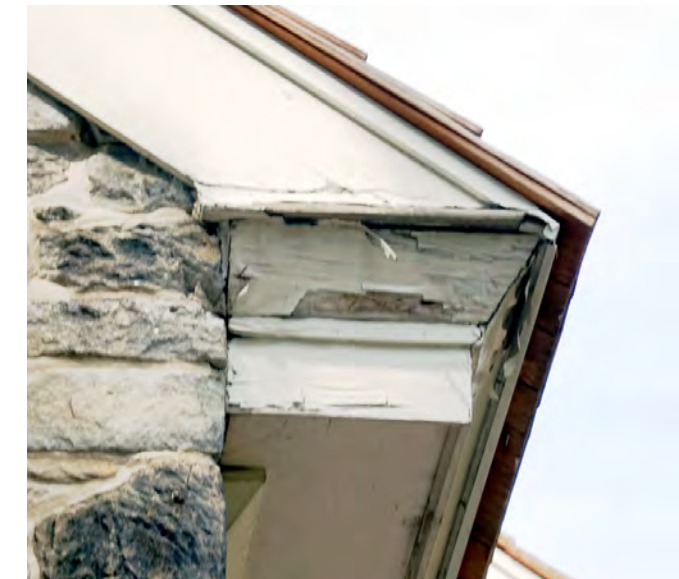
B WOOD REPAIRS @ CORNICE
REPAIR CORNICE RETURN

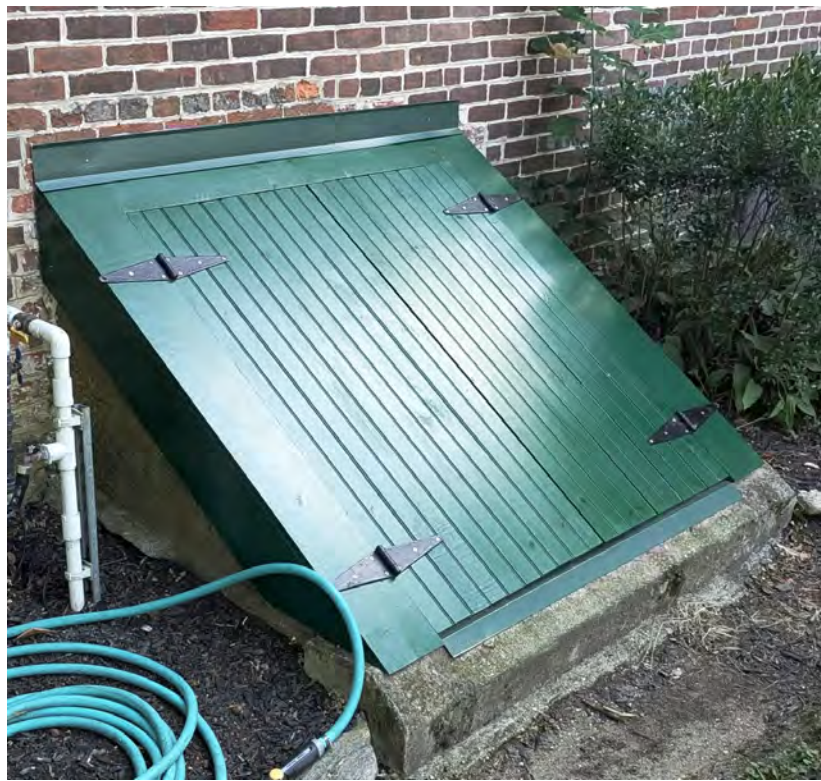
E WOOD REPAIRS - BULKHEAD DOOR
INSTALL ASTRAGAL ON RECENTLY INSTALLED BULKHEAD DOORS

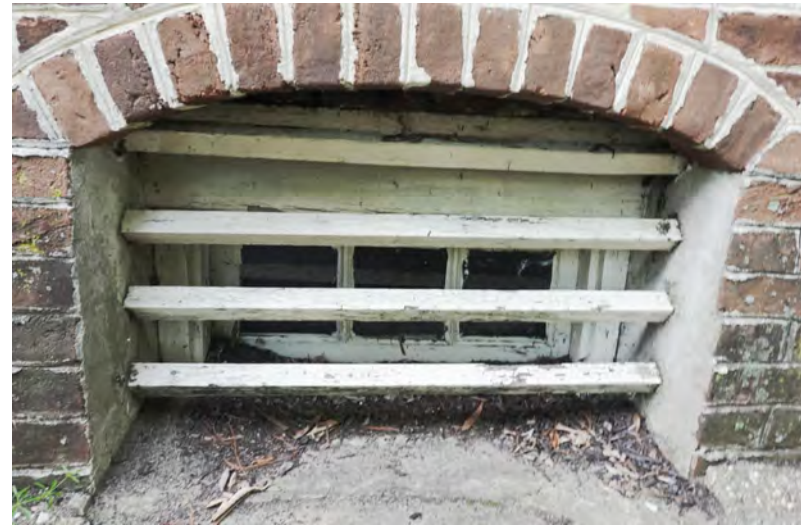
D WOOD REPAIRS
EPOXY CONSOLIDATE LOWER BAR AT BASEMENT WINDOW.

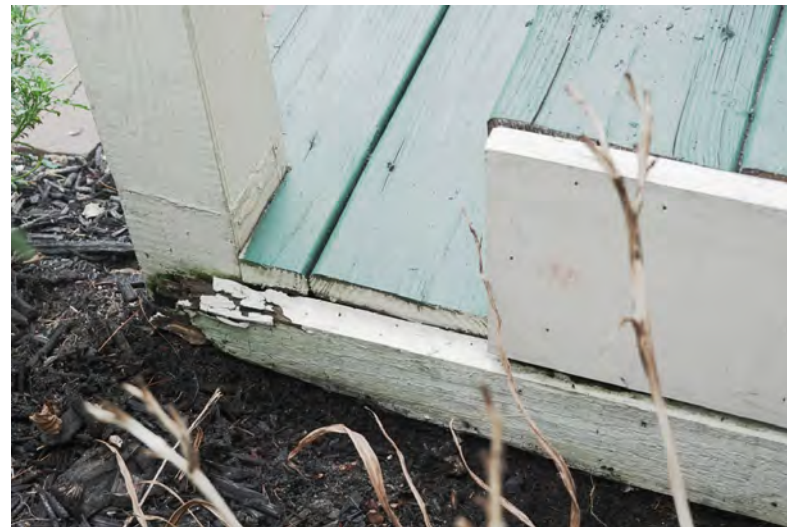
C WOOD REPAIRS
DUTCHMAN REPAIR ROTTED AREA OF SKIRT BOARD AT STOOP.

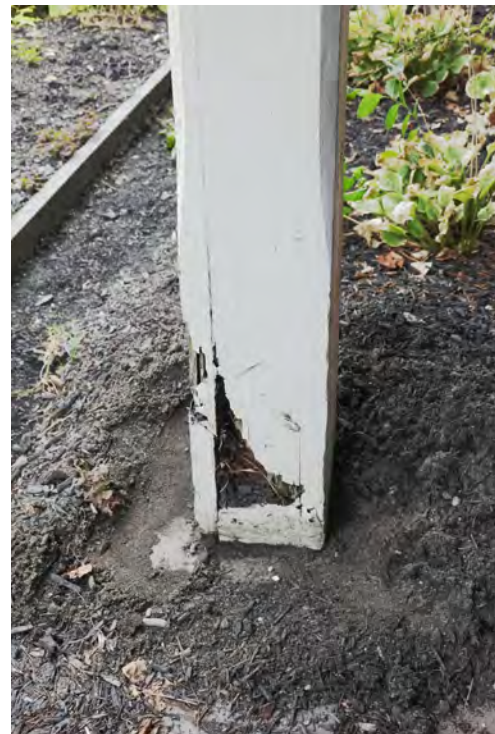
B WOOD REPAIRS @ POSTS
REPAIR/REPLACE WOOD POST BOARDS. REGRADE AT BASE TO MINIMIZE POTENTIAL FOR FUTURE DAMAGE. (4 POSTS TYP.)

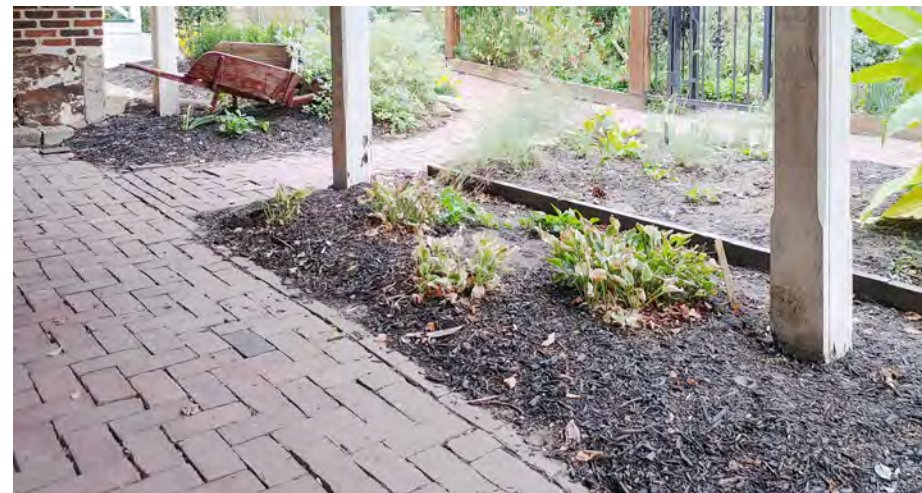
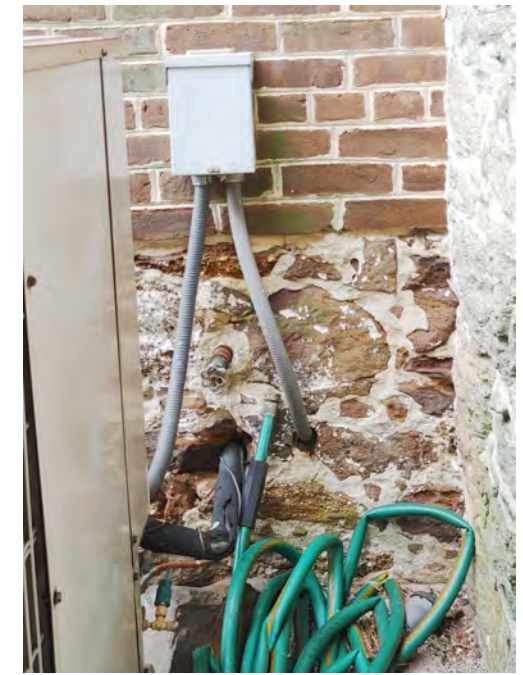
A WALL PENETRATIONS
CAULK ALL OPEN WALL PENETRATIONS. REPLACE PREVIOUS CAULK/PATCHING MATERIAL WHERE DETERIORATED, LOOSE OR DISCOLORED..

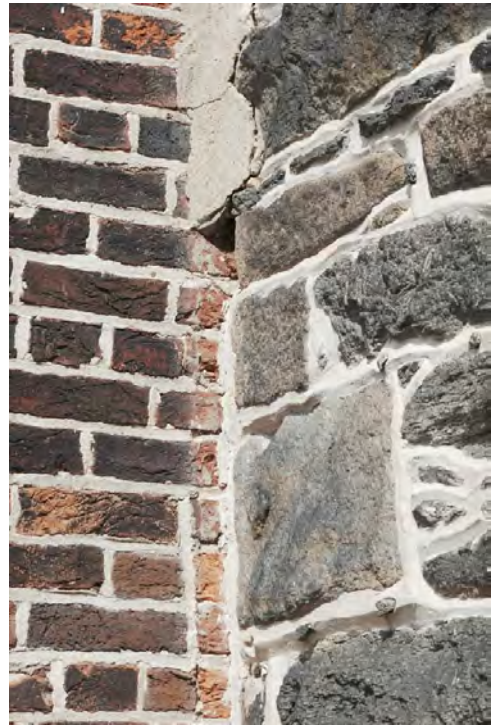
B REPAIR CORNER JOINT

PATCH REPAIR INSIDE CORNER BETWEEN BRICK AND STONE WALL. REMOVE LOOSE MORTAR, FILL HOLES w/ BACKER ROD & TUCK POINT.

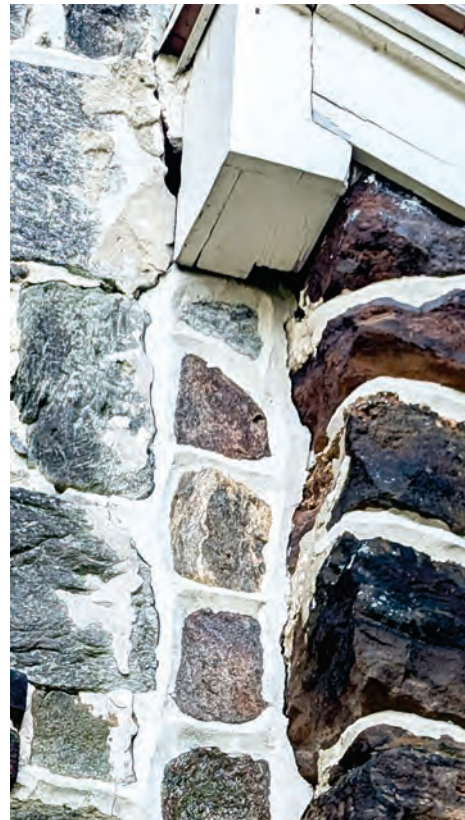
C REPAIR MORTAR

REMOVE LOOSE MORTAR, FILL DEEP HOLES @ TRIM w/ BACKER ROD & TUCK POINT JOINTS.

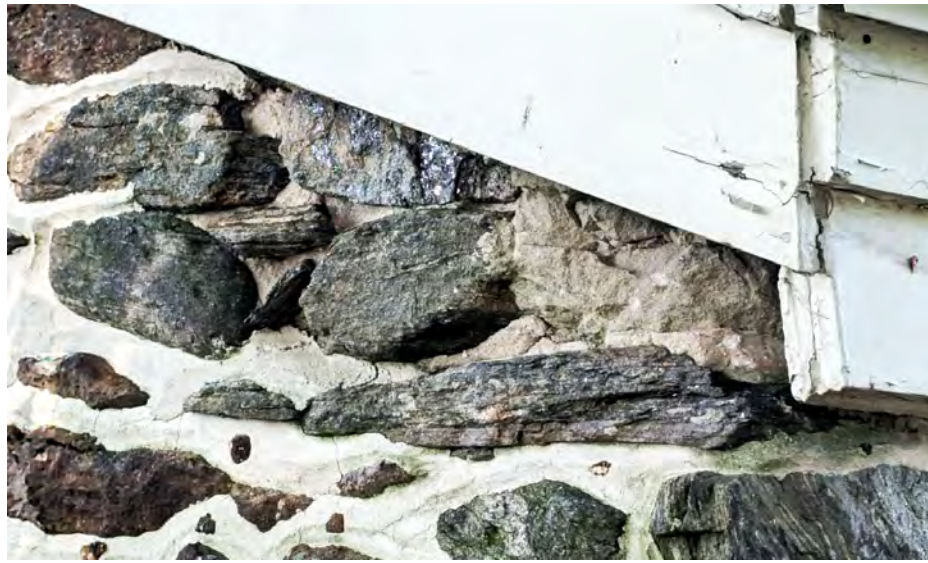
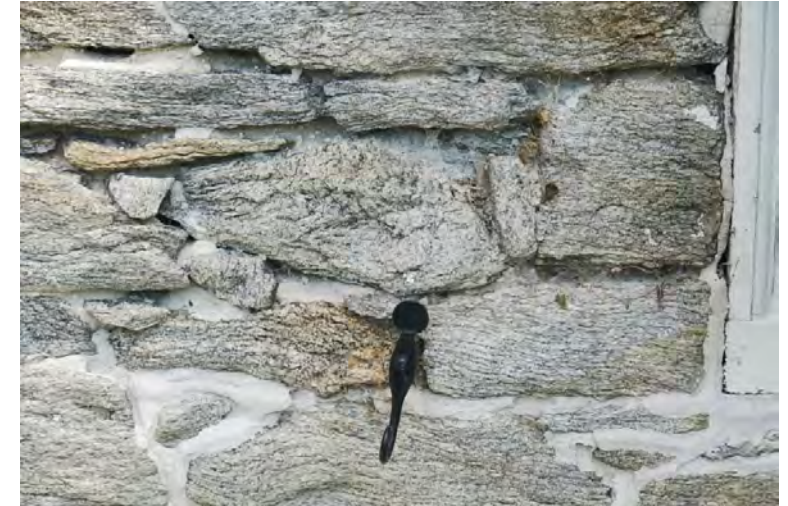
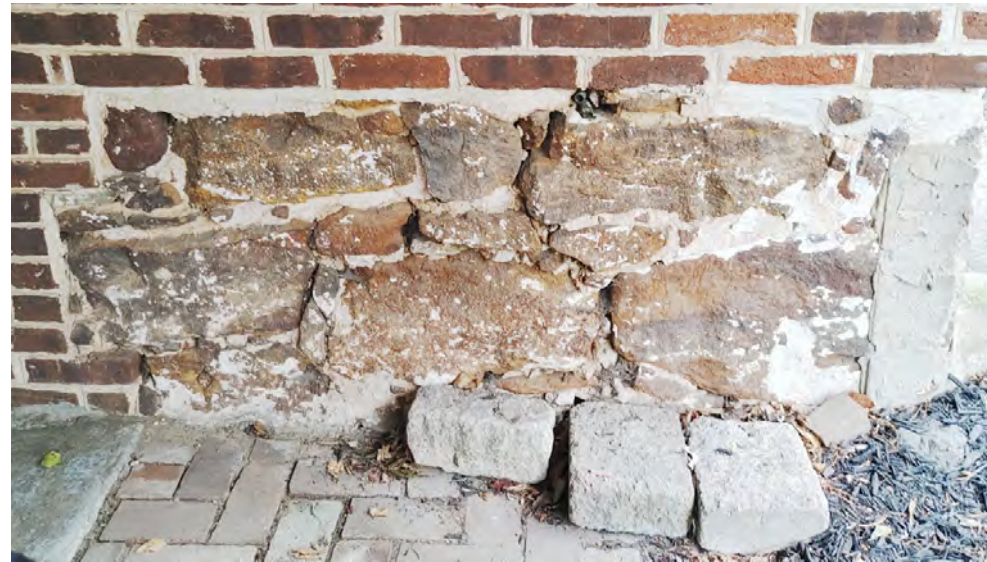
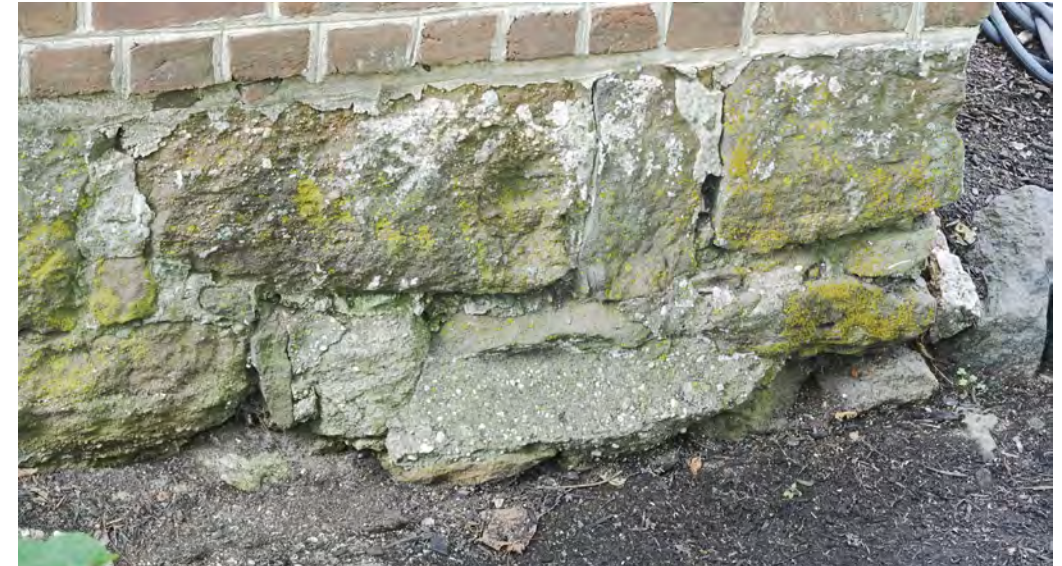
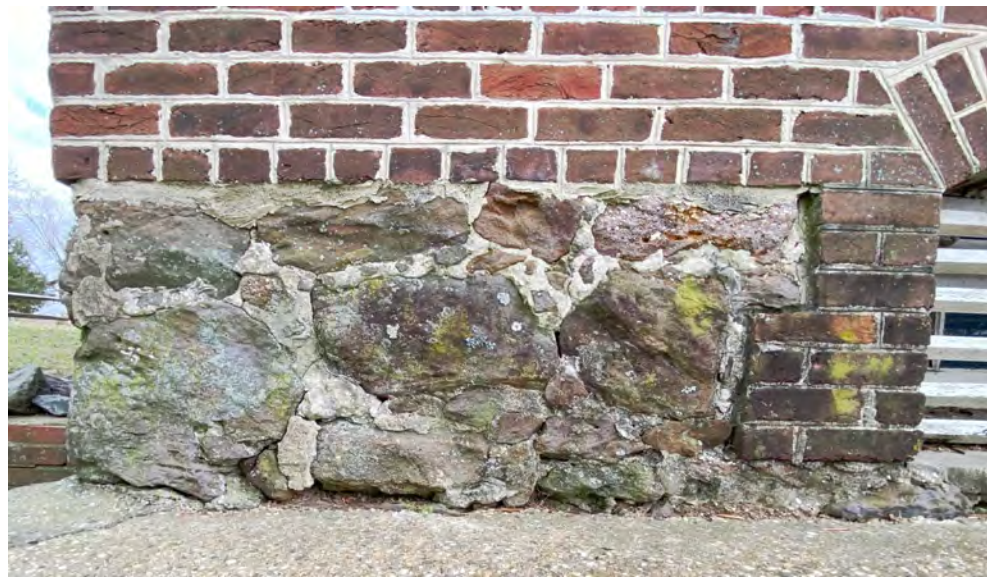
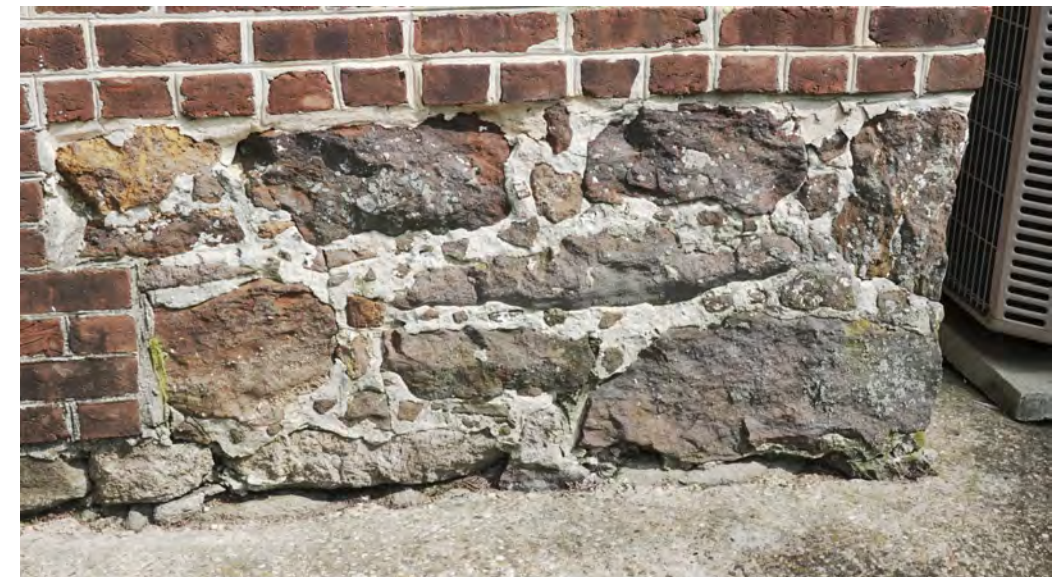
A STONE REPAIRS

REPRESENTATIVE PHOTOS SHOWING EXAMPLES OF STONE WITH DETERIORATED JOINTS IN NEED OF TUCK POINTING. SEE ELEVATION PHOTOS FOR DOCUMENTATION OF LOCATIONS.

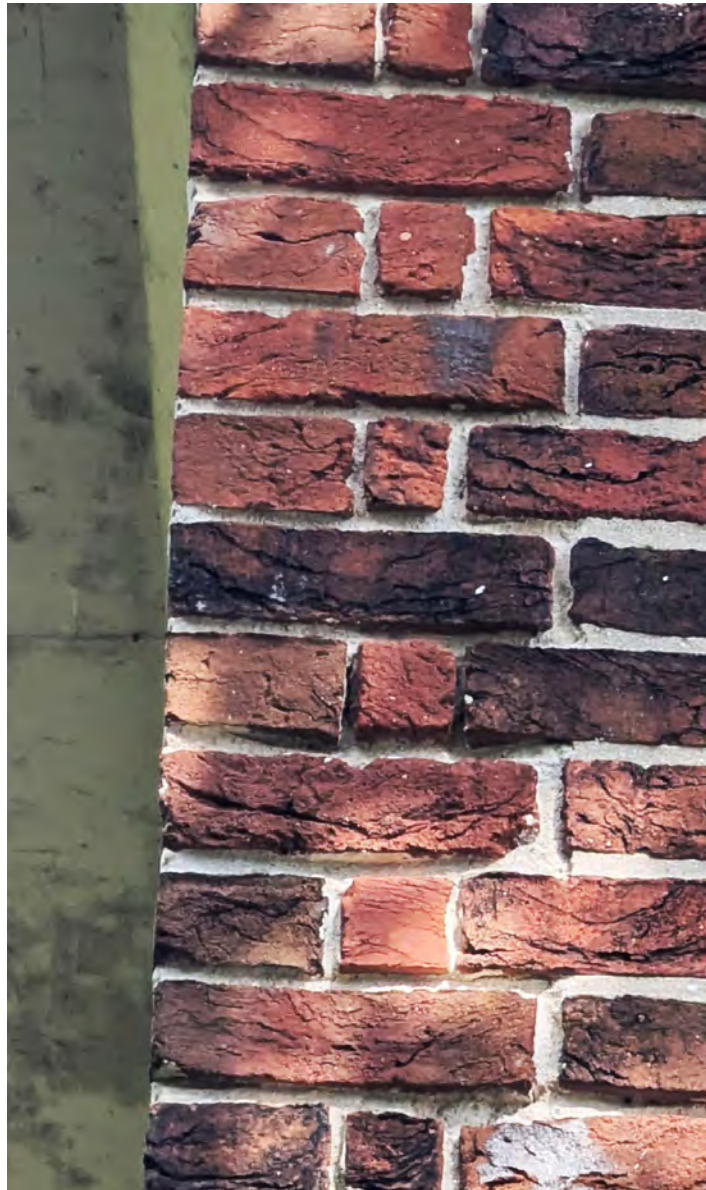
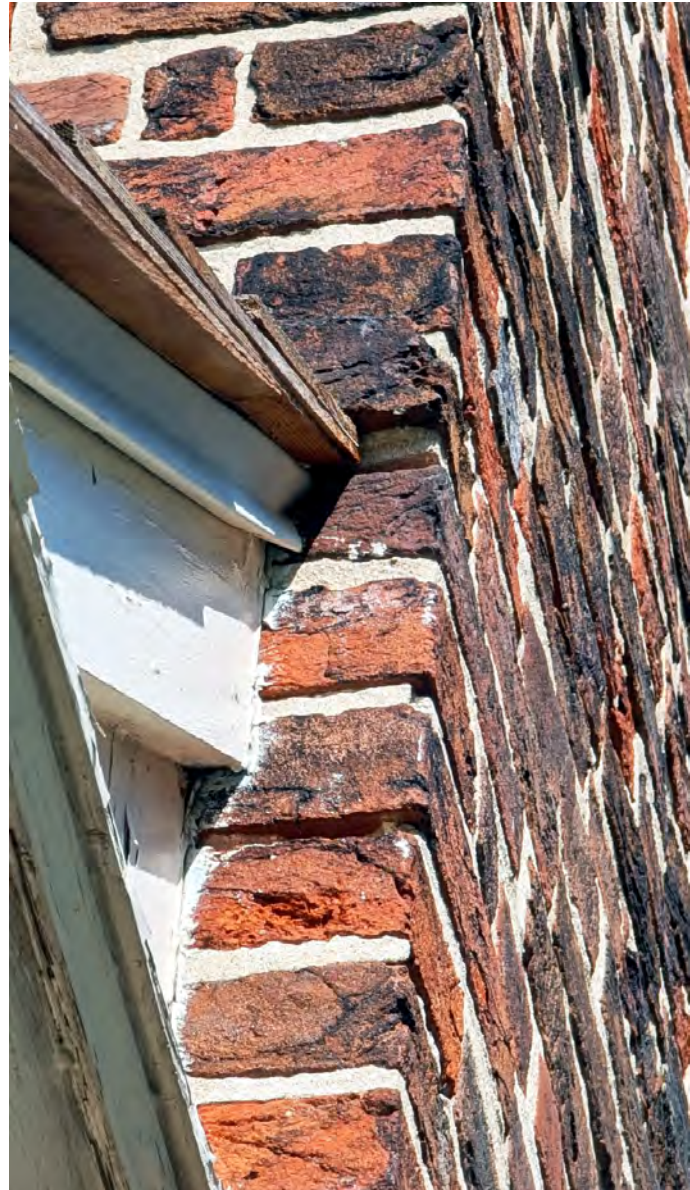
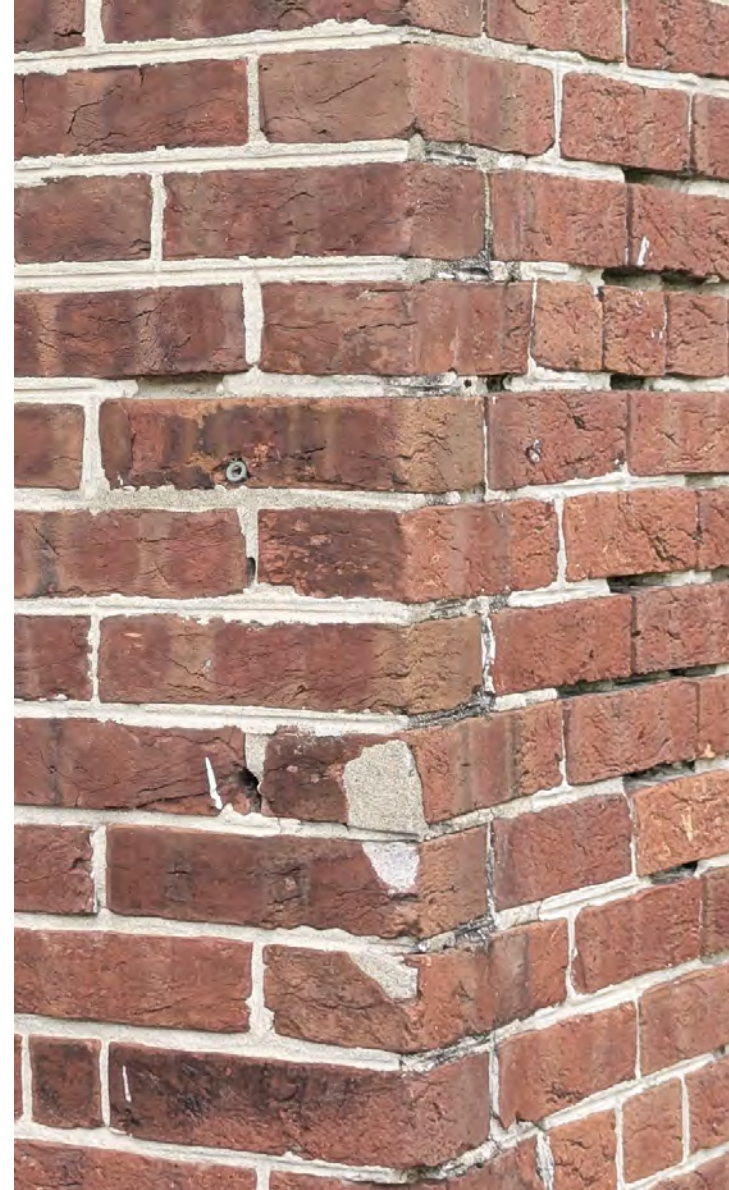
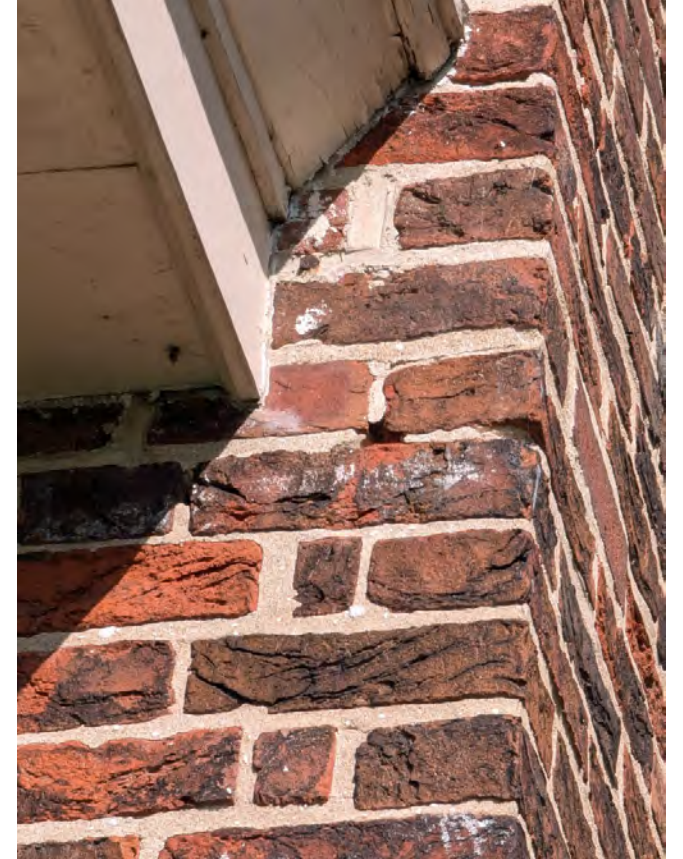
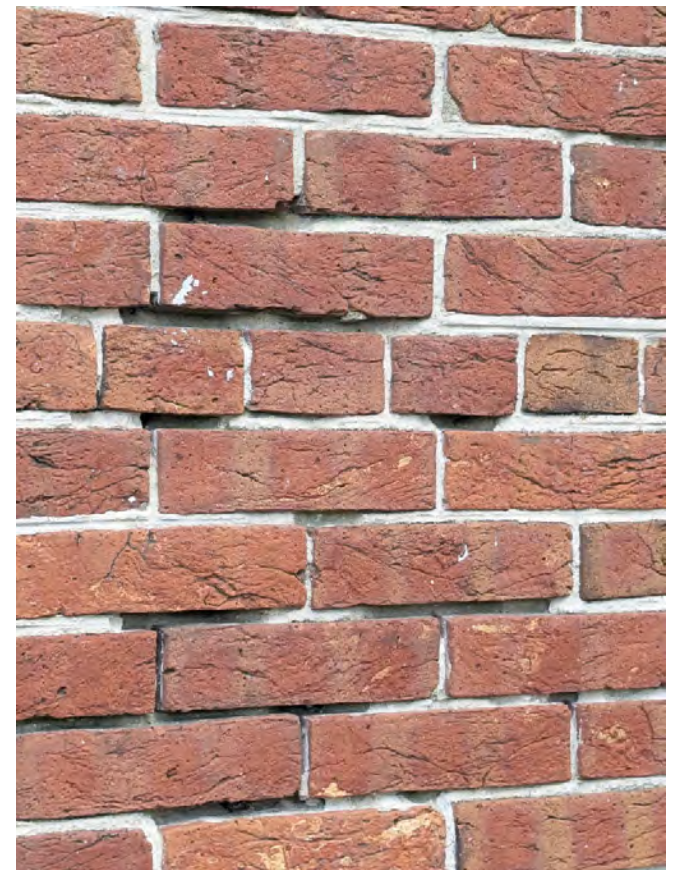
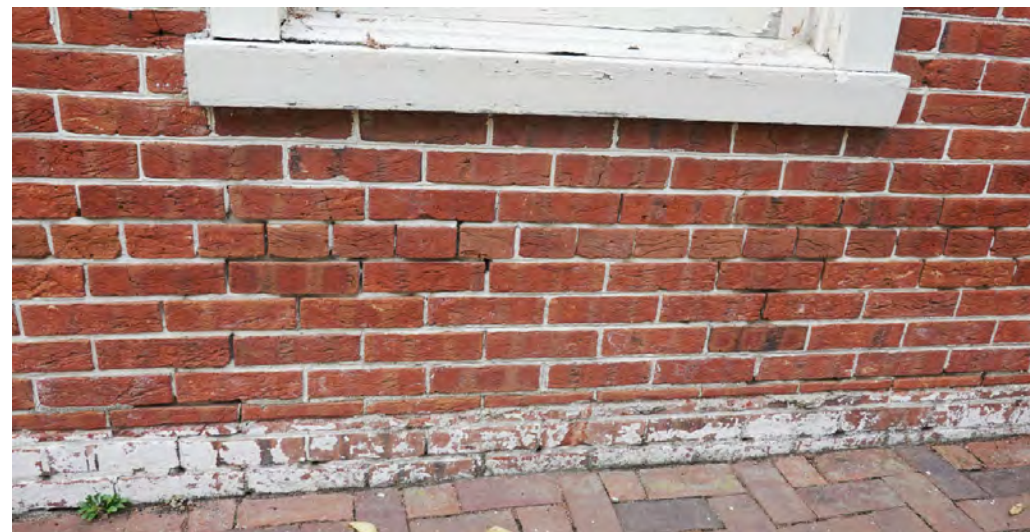
A BRICK REPAIRS, TYP.
 REPRESENTATIVE VIEWS SHOWING EXAMPLES OF OPEN BRICK JOINTS IN NEED OF REPOINTING.
 SEE ELEVATIONS FOR DOCUMENTATION OF LOCATIONS.

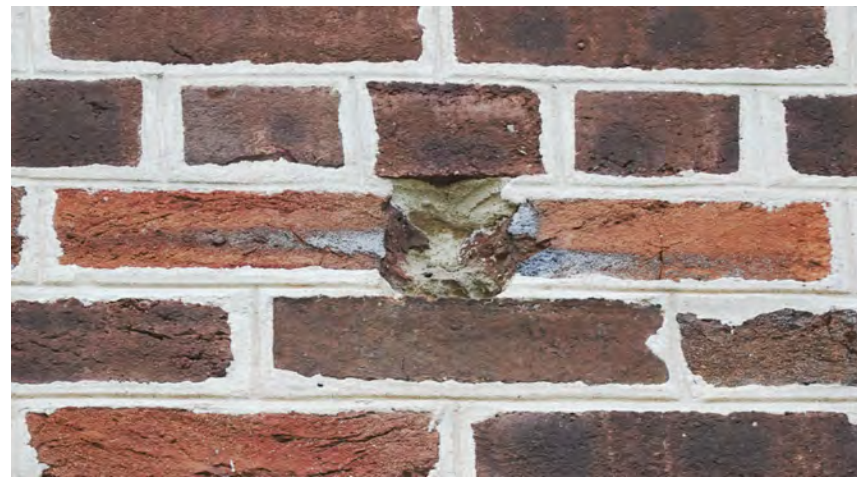
C BRICK REPAIR
 CLEAN OUT HOLE IN BRICK, REMOVE FILLER. PATCH BRICK FACE WITH TINTED MORTAR OR APPROVED PATCHING MATERIAL, AND RESTORE MORTAR JOINTS

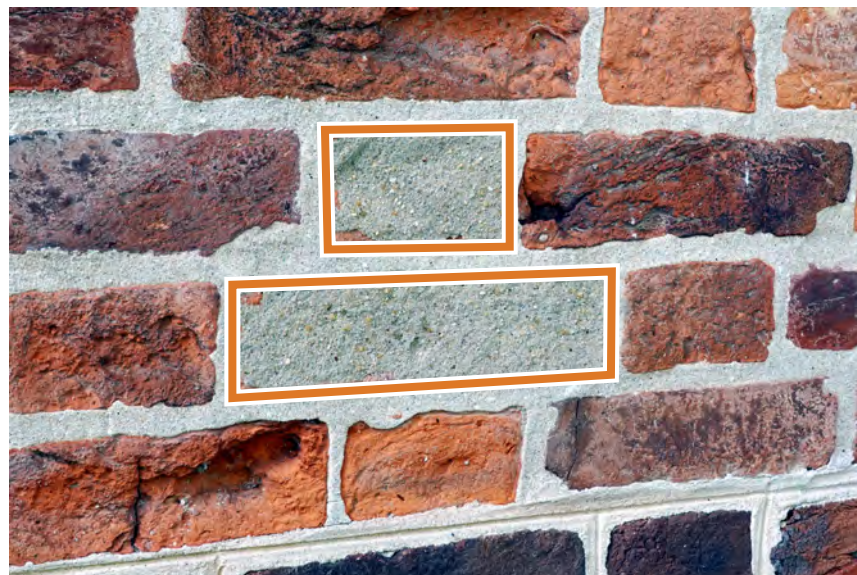
B BRICK REPAIRS
 REMOVE MORTAR FROM TWO BRICK FACES, FILL w/ TINTED MORTAR OR OTHER APPROVED PATCHING MATERIAL.
