EXTERIOR RESTORATION

James and Ann Whitall House
100 Hessian Avenue, National Park, NJ 08063

Westfield Architects & Preservation Consultants
425 White Horse Pike, Haddon Heights, NJ 08035

FOR BIDDING
REV. 8/2/24

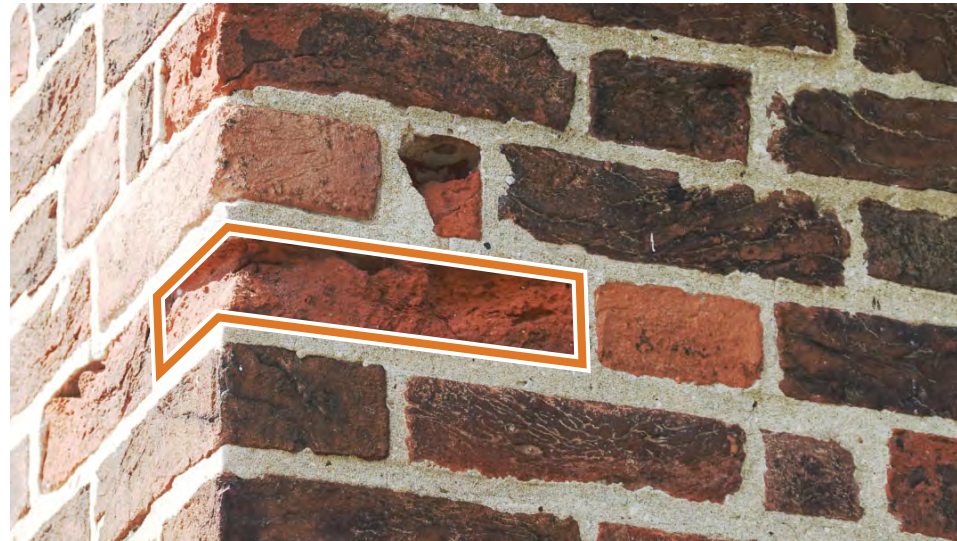
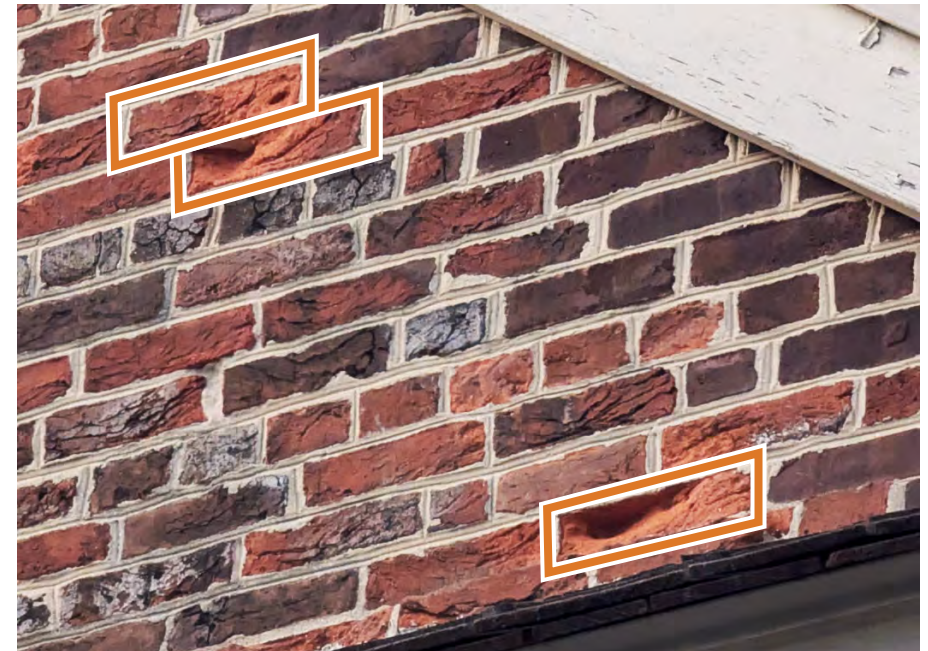
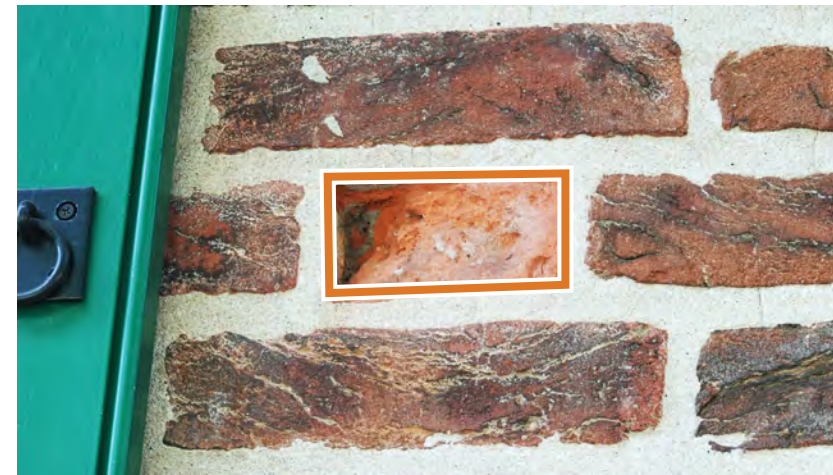
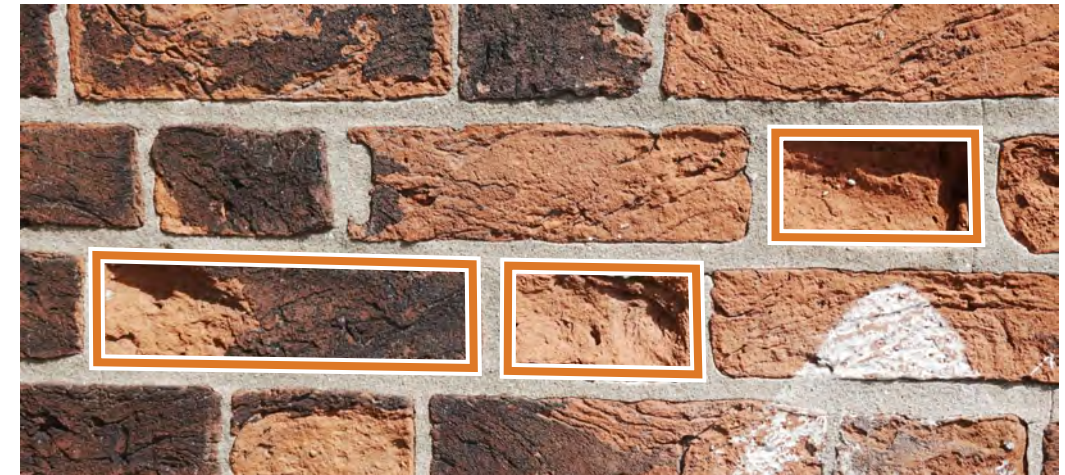
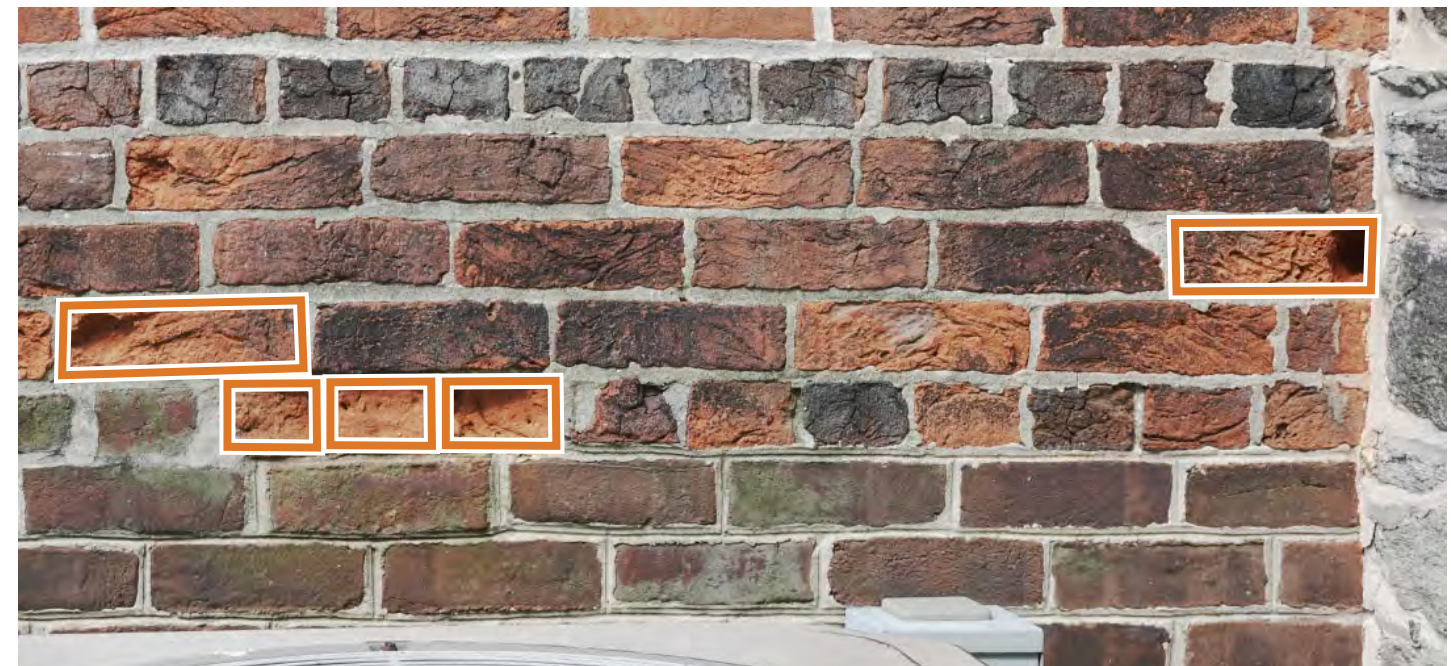
A BRICK REPAIRS
 REPRESENTATIVE PHOTO SHOWING EXAMPLES OF BRICK FACES IN NEED OF REPAIR. PATCH DAMAGED BRICK FACES w/ TINTED MORTAR OR APPROVED PATCHING MATERIAL. SEE ELEVATION PHOTOS FOR DOCUMENTATION OF LOCATIONS.
