EXTERIOR RESTORATION

James and Ann Whitall House
100 Hessian Avenue, National Park, NJ 08063

Westfield Architects & Preservation Consultants
425 White Horse Pike, Haddon Heights, NJ 08035

FOR BIDDING
REV. 8/2/24

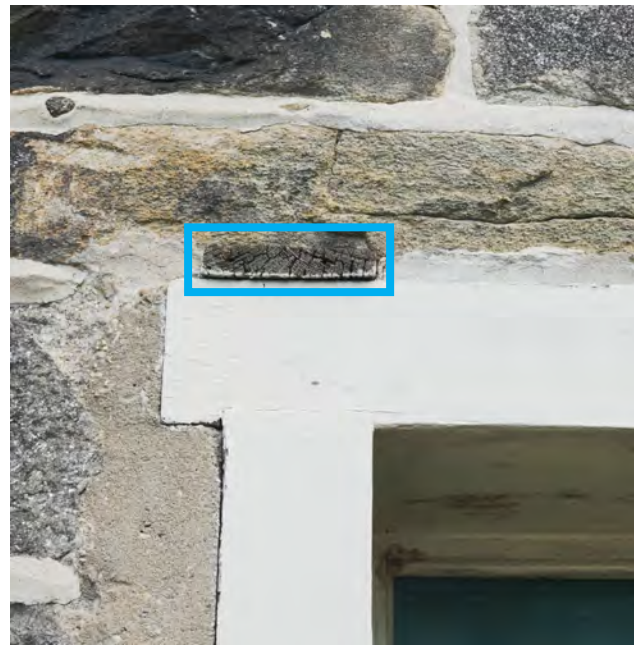
E EXTERIOR ABOVE DOOR
REMOVE EMBEDDED PIECE OF WOOD ABOVE DOOR HEAD. FILL w/ BACKER ROD, MORTAR & CAULK JOINT @ WOOD DOOR FRAME

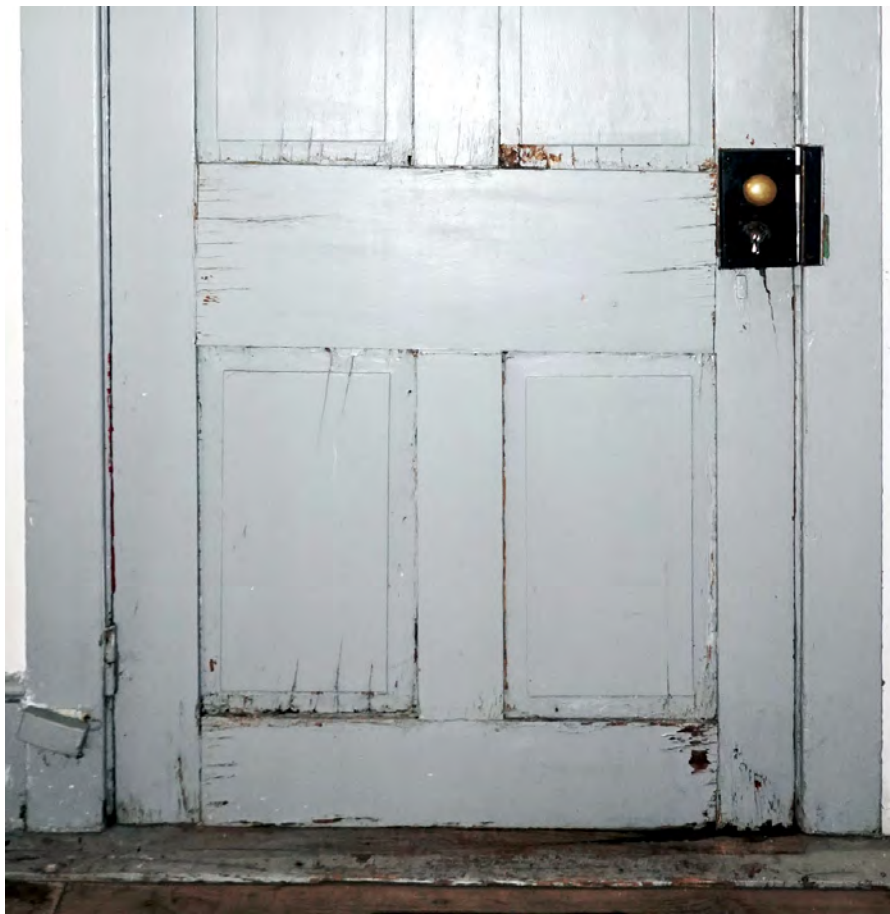
F INTERIOR VIEW OF DOOR

G DOOR D4
REPAIR FRAME, REHANG DOOR, PATCH MORTAR, CAULK JAMBS & HEAD. INSTALL NEW SILL WEATHERSTRIPPING.

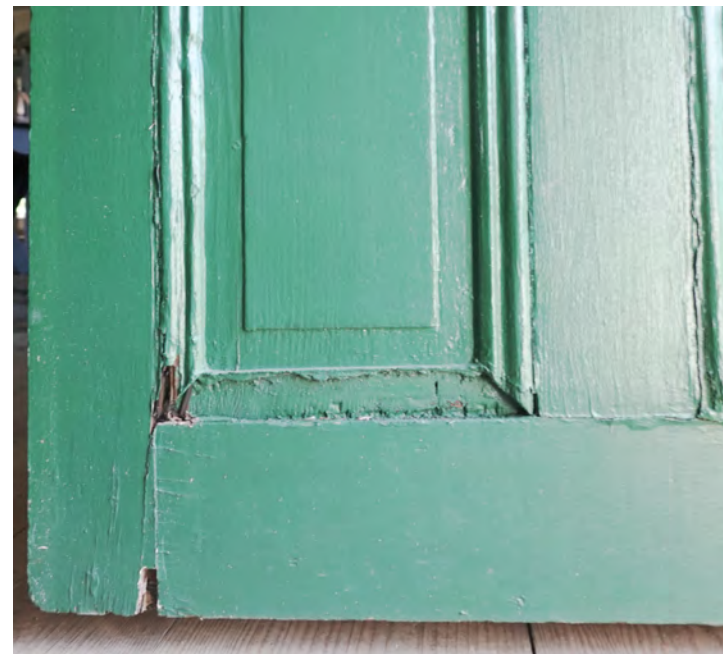
C EXTERIOR VIEW OF DOOR

DOOR D2
EPOXY REPAIR DOOR, REPLACE MISSING MOLDING, INTERIOR & EXTERIOR. REPAIR JAMB AT HINGE LOCATIONS, REHANG DOOR.

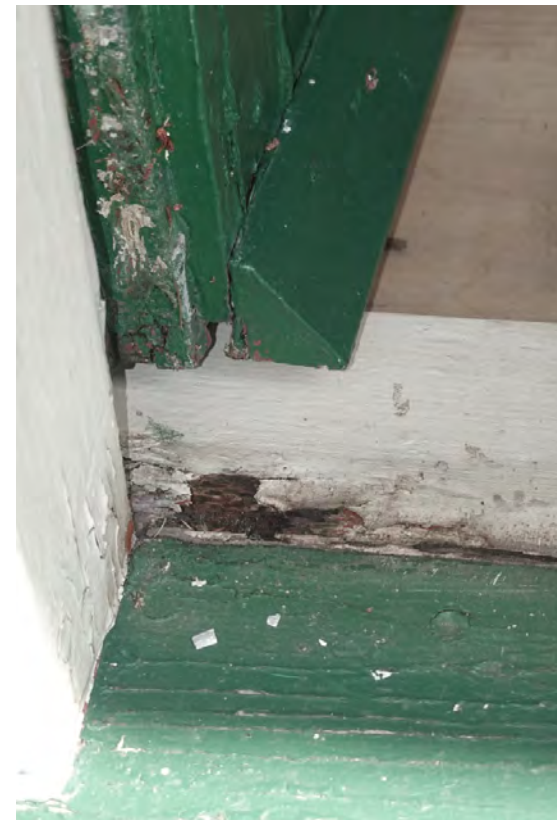
B INTERIOR VIEW OF THRESHOLD

DOOR D1
REPLACE INTERIOR WOOD RAMPED THRESHOLD. EPOXY REPAIR KERFED EXTERIOR JAMB TRIM, BOTH SIDES.

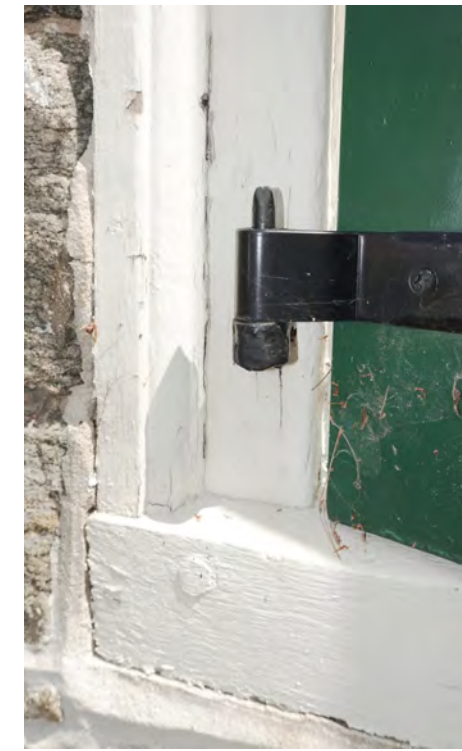
B LOWER LEFT JAMB

WINDOW **W1**

EPOXY REPAIR WINDOW JAMB TRIM AT ALL PINTLE LOCATIONS. REINSTALL SHUTTER
HARDWARE & REHANG SHUTTERS.

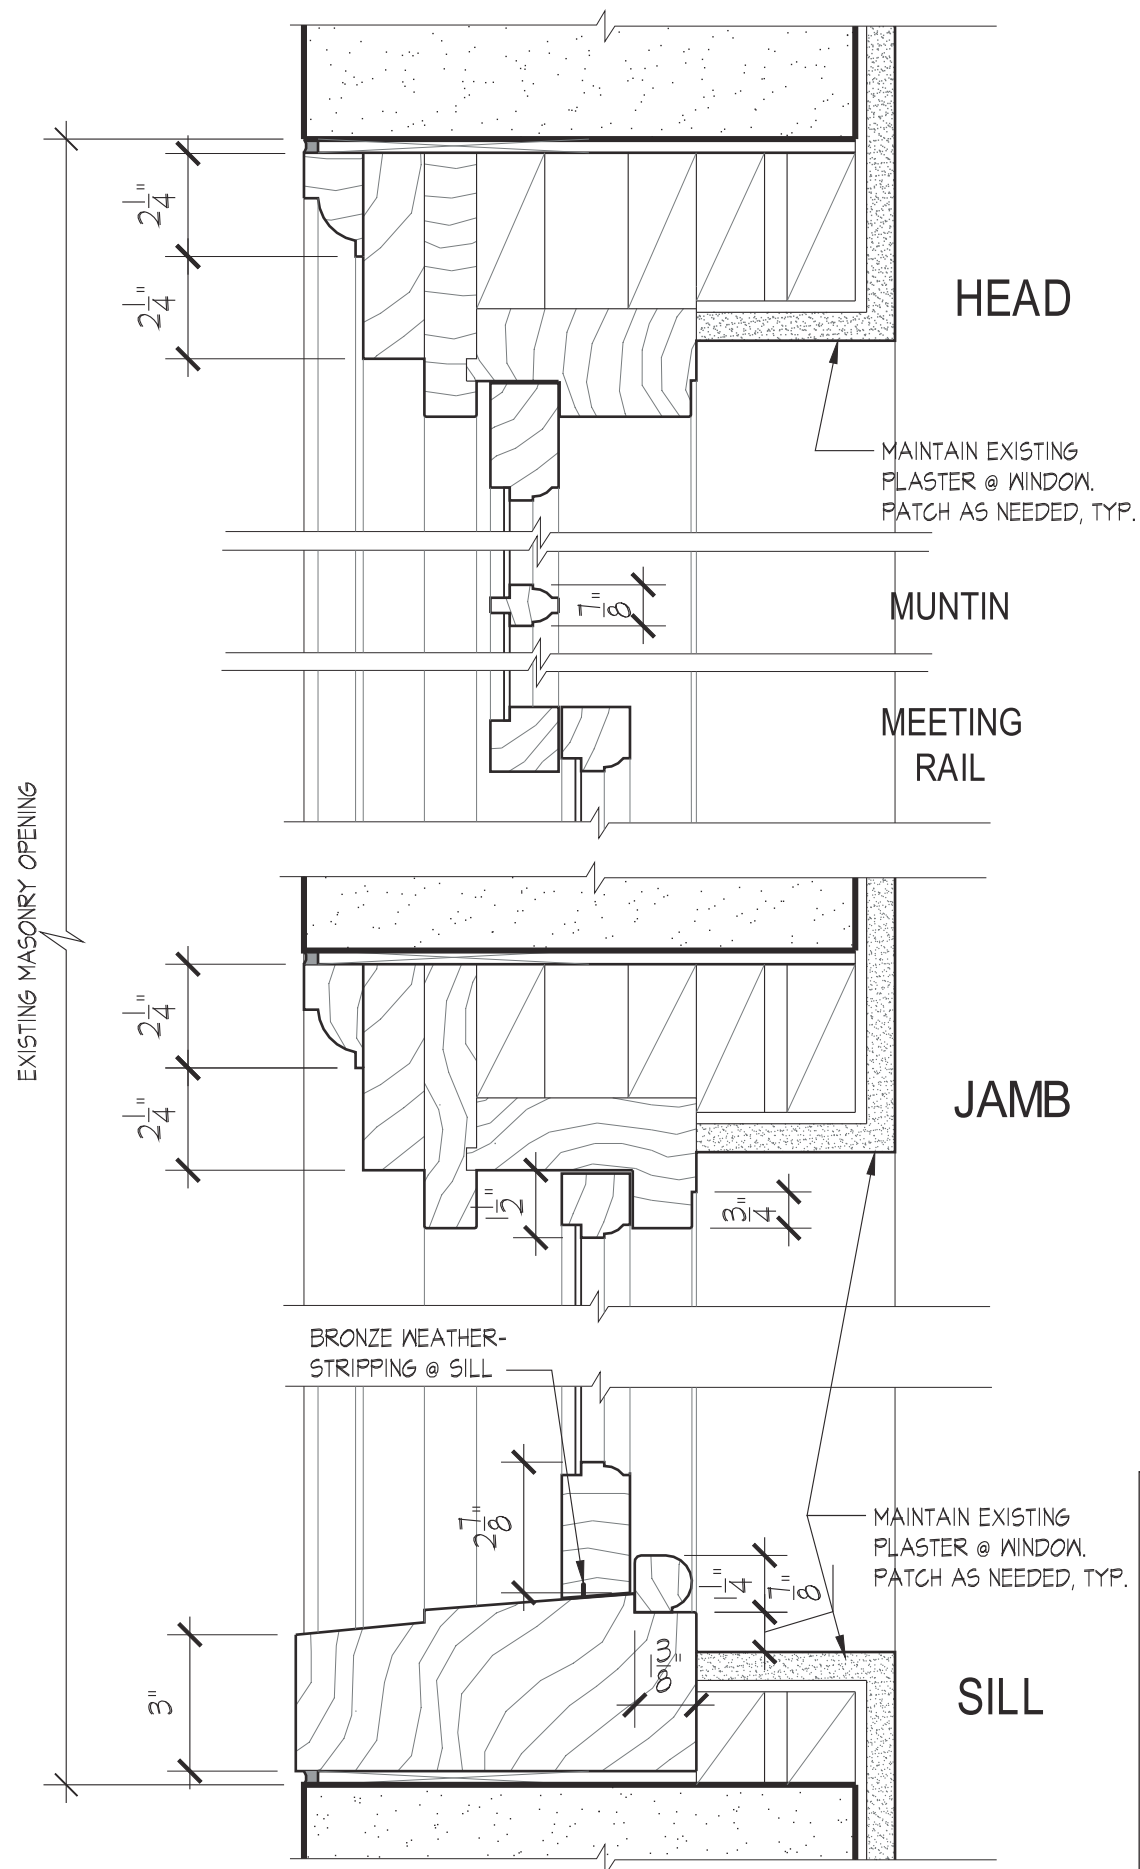
1 SECTION - REPLACEMENT WINDOW W2
NTS

NOTE:
DIMENSIONS AND CONFIGURATION OF WINDOW COMPONENTS SHOWN IN THIS SECTION ARE DERIVED FROM THE 1935 HABS DOCUMENTATION AND MAY NOT REFLECT ALTERATIONS MADE SINCE. THE INTENT IS TO REPLICATE THE DETAILING OF WINDOW W1. CONFIGURATION AND CONDITION OF THE LINTEL, FRAMING & BLOCKING WILL NEED TO BE CONFIRMED. VERIFY CONDITIONS AND SUBMIT SHOP DRAWINGS FOR APPROVAL BEFORE PROCEEDING WITH FABRICATING REPLACEMENT WINDOW.

REMOVE ENTIRE EXISTING WINDOW, FRAME & TRIM. ENSURE BLOCKING @ OPENING IS SUFFICIENT FOR NEW WINDOW. INSTALL NEW WINDOW & TRIM. REPOINT ANY LOOSE OR MISSING MORTAR AT OPENING PER UNIT PRICE.

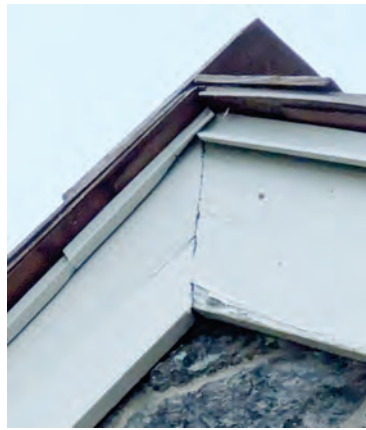
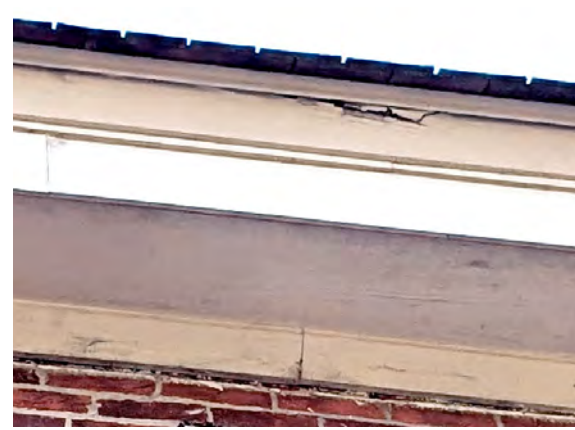
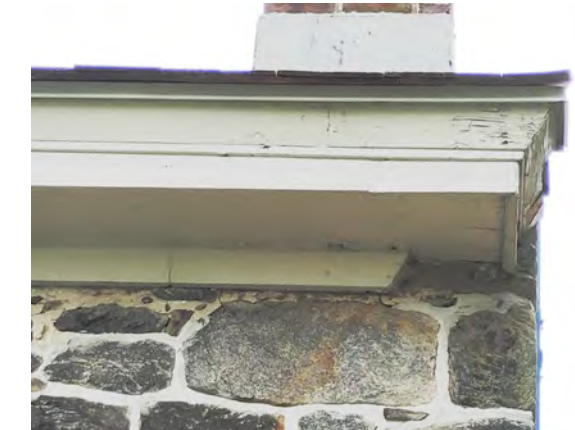
G WOOD REPAIR EXAMPLES OF TYPICAL CONDITIONS IN NEED OF REPAIRS @ CORNICE, FASCIA, RAKE BOARD & MOLDING - SEE ELEVATION PHOTOS FOR SPECIFIC LOCATIONS.

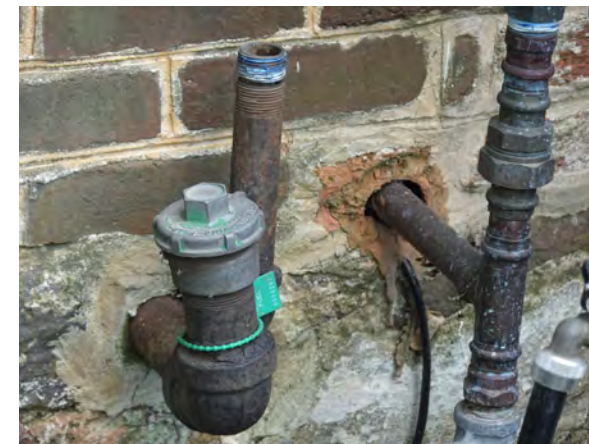
A WALL PENETRATIONS
CAULK ALL OPEN WALL PENETRATIONS. REPLACE PREVIOUS CAULK/PATCHING MATERIAL WHERE DETERIORATED, LOOSE OR DISCOLORED..

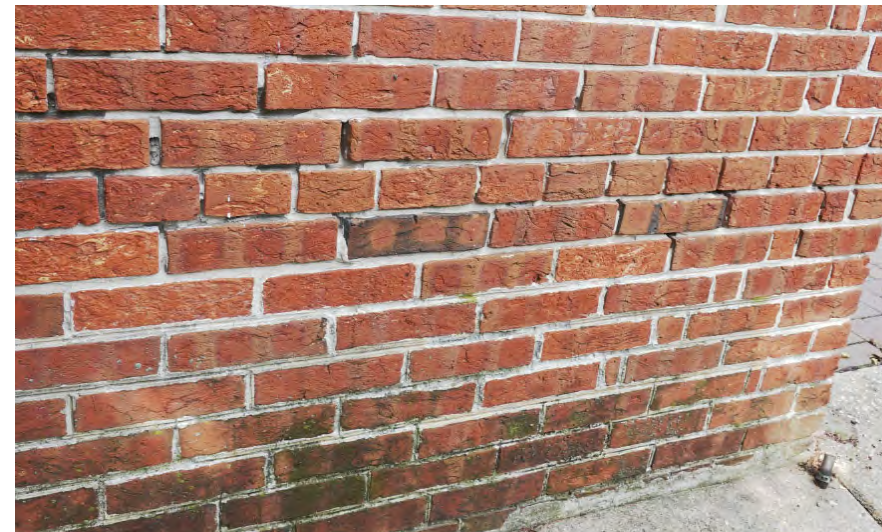
A BRICK REPAIRS, TYP.
 REPRESENTATIVE VIEWS SHOWING EXAMPLES OF OPEN BRICK JOINTS IN NEED OF REPOINTING.
 SEE ELEVATIONS FOR DOCUMENTATION OF LOCATIONS.
